**DEPARTMENT OF TRANSPORTATION**

Quality Assurance and Source Inspection

Contract #: 04-0120F4Cty: SF/ALA Rte: 80 PM: 13.2/13.9File #: 1.28**WELDING INSPECTION REPORT****Resident Engineer:** Casey, William**Address:** 333 Burma Road**City:** Oakland, CA 94607**Report No:** WIR-028376**Date Inspected:** 11-Sep-2012**Project Name:** SAS Superstructure**OSM Arrival Time:** 700**Prime Contractor:** American Bridge/Fluor Enterprises, a JV**OSM Departure Time:** 1930**Contractor:** American Bridge/Fluor Enterprises, a JV**Location:** Job Site**CWI Name:** Fred Michels and Cris Concha**CWI Present:** Yes No**Inspected CWI report:** Yes No N/A**Rod Oven in Use:** Yes No N/A**Electrode to specification:** Yes No N/A**Weld Procedures Followed:** Yes No N/A**Qualified Welders:** Yes No N/A**Verified Joint Fit-up:** Yes No N/A**Approved Drawings:** Yes No N/A**Approved WPS:** Yes No N/A**Delayed / Cancelled:** Yes No N/A**Bridge No:** 34-0006**Component:** SAS OBG**Summary of Items Observed:**

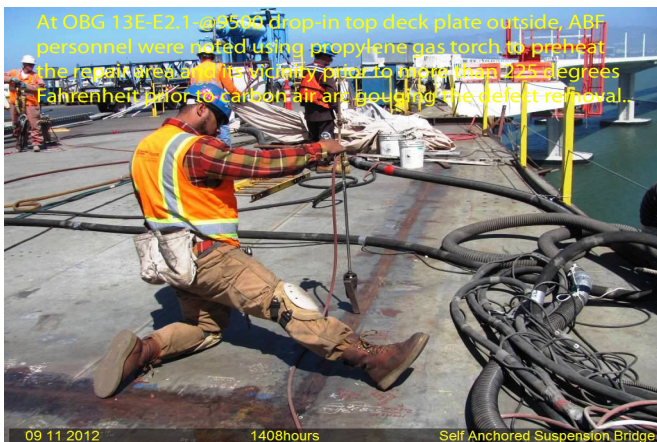
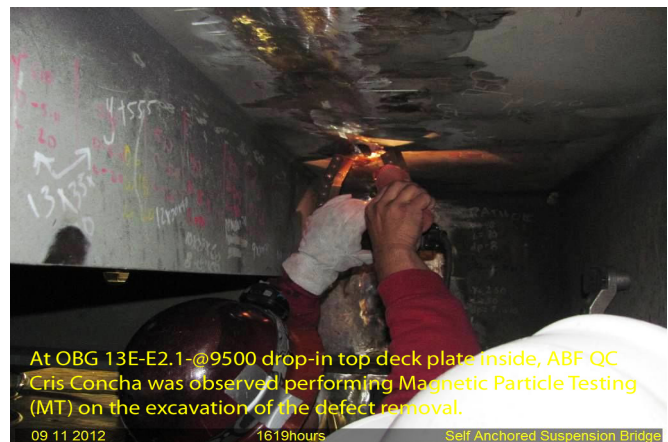
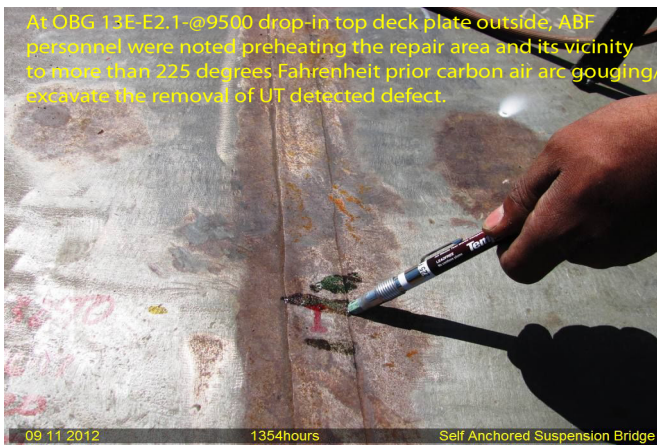
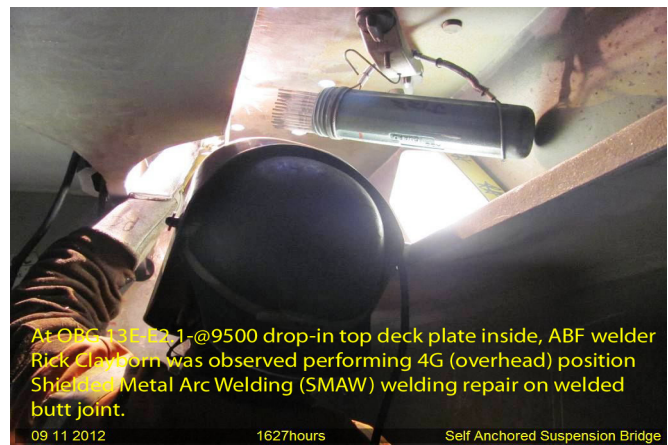
At OBG 13E-E2.1-@9500 drop-in top deck plate inside, QA randomly observed ABF/JV qualified welder Rick Clayborn continuing to perform CJP groove welding repair on a Seismic Performance Critical Member (SPCM) due to Ultrasonic Testing (UT) detected defect on welded splice butt joint. The welder preheated the repair area and its vicinity to >225°F using propylene gas torch prior excavation and then ground smooth the groove of the excavation. After its completion, ABF QC Cris Concha performed Magnetic Particle Testing (MT) on the removal of the defects with no relevant defect noted during the test. This QA also performed same test verification with same result noted.

ABF personnel were noted using propylene gas torch to preheat the repair area and its vicinity to 325°F and as soon as the required temperature was attained the welder started performing the welding repair. Welder Rick Clayborn was observed manually welding in 4G (overhead) position utilizing Shielded Metal Arc Welding (SMAW) with 3.2mm diameter E7018H4R electrode implementing Caltrans approved welding procedure ABF-WPS-D15-1004 Repair. Welder Rick Clayborn was noted welding five (5) first time and two (2) second time repairs at various Y locations listed below. During welding, ABF QC Fred Michels was noted monitoring the welder from the inside while Cris Concha was noted monitoring the welders' welding parameter from the outside with measured working current of 136 amperes on the 3.2mm diameter E7018H4R electrode. Since the two (2) second time repairs need an approved Request for Weld Repair (RWR) prior to commence the repair, this QA has

informed ABF QC Cris Concha about the need for the RWR prior repair. Also, according to ABF QC Fred Michels he had informed the welder that the two such repair still awaiting Caltrans approval. Despite this notice given by the QC to the welder forewarning him not to proceed with the two repairs, the welder performed the two repairs and completed them during the shift without the approved RWR. Since this was in violation to the procedure per contract documents, this QA issued an Incident Report. Each time the welder has completed one repair, an ABF personnel was noted performing the post weld heat treatment (PWHT) using the propylene gas torch and verifying the heat using the 450°F for one hour as required. Another ABF personnel were also noted continuously preheating the repair area and its vicinity to 325°F as the welder goes to another repair. ABF welder Rick Clayborn has completed from inside the first and second time repairs listed below;

Y-location	Length	Width	Depth	RWR#	Remarks
1. 8050mm	50mm	20mm	9mm	N/A	R1- completed.
2. 3240mm	150mm	20mm	12mm	N/A	R1- completed.
3. 2650mm	70mm	20mm	8mm	Required R2	– completed.
4. 2120mm	50mm	20mm	5mm	N/A	R1- completed.
5. 1210mm	40mm	20mm	8mm	Required R2	– completed.
6. 1075mm	100mm	15mm	9mm	N/A	R1- completed.
7. 3590mm	50mm	20mm	10mm	N/A	R1- completed.
